Manhole Inspection Summary

Manhole # S25CC_006MH

Insp Date: **10/17/07 9:35 AM**

Location Address: **1046 ARLINGTON AVE**

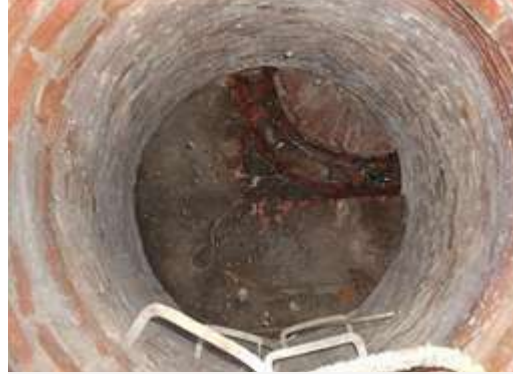
Top View

Evidence of surcharge - Bench debris.
Channel debris.

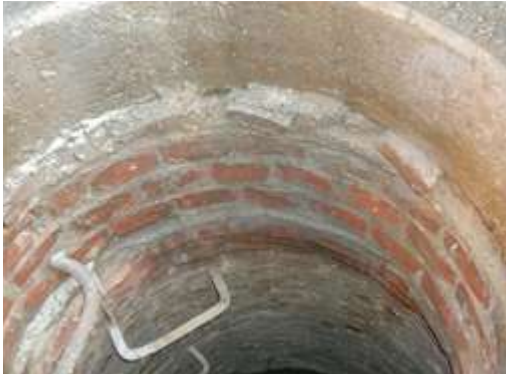
Defect

Frame leaks. Adjustment deterioration
and infiltration. Barrel infiltration - other
side.

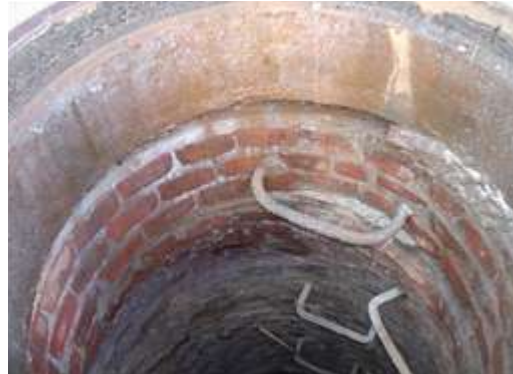
Defect

Frame leaks. Adjustment deterioration
and infiltration. Barrel infiltration.

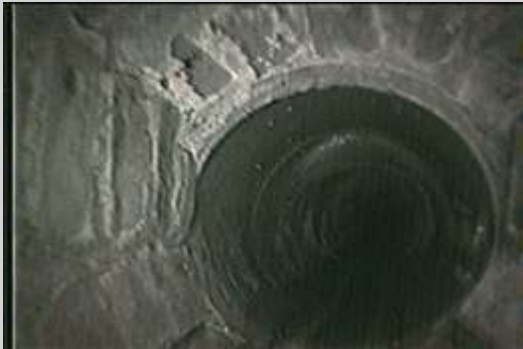
Pipe Out @ 12 O'Clock

Infiltration: **Evidence** Pipe Seal Cond: **Unknown**
